Update on aLIGO PSL PMC upgrade to address contamination issues

Jian Liu and Rick Savage
(with S. Appert, P. King, E. Sanchez, L. Zhang, et al.)

SYS telecon
Aug. 9, 2017

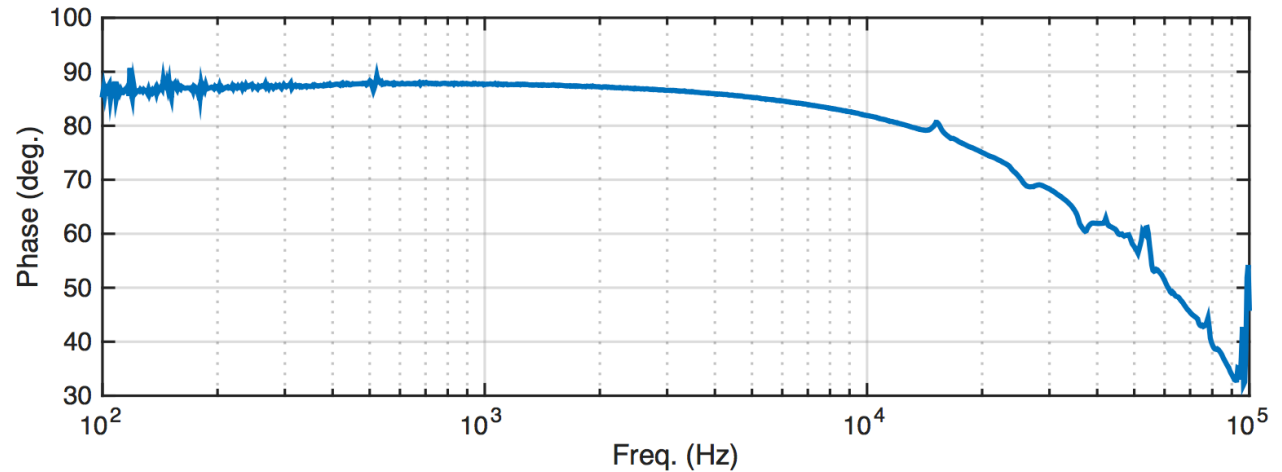
Laser frequency locking servo – open loop transfer function

- Laser frequency locked to cavity resonance using PDH scheme.
 - » See [LIGO-T1600204](#) for servo locking details
 - » Loop UGF ~20 kHz

- PZT actuator driven directly with dynamic signal analyzer source output (SRS up to 100 kHz, Agilent RF analyzer for higher frequencies)

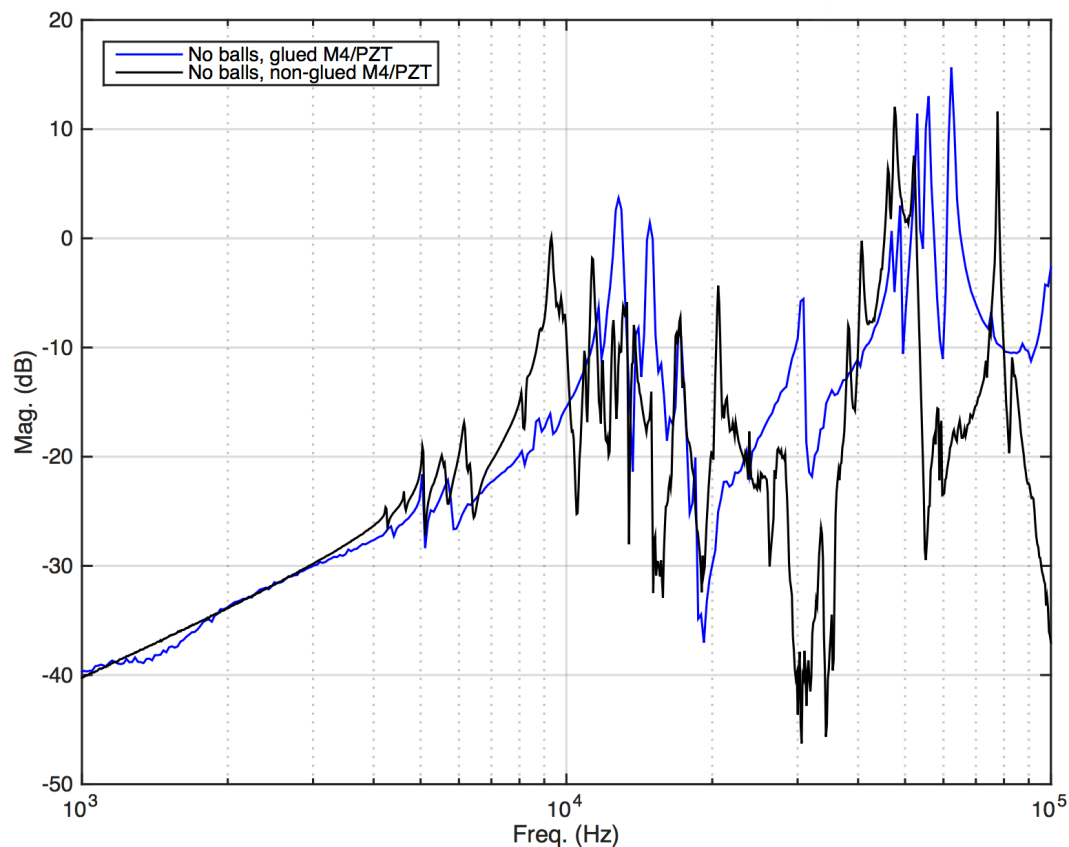
Glued M4/PZT assembly (SN02) compare glued and non-glued

- Glued M4/PZT assembly (SN02) on 1st Aug.
- Measured the parallelism before gluing.

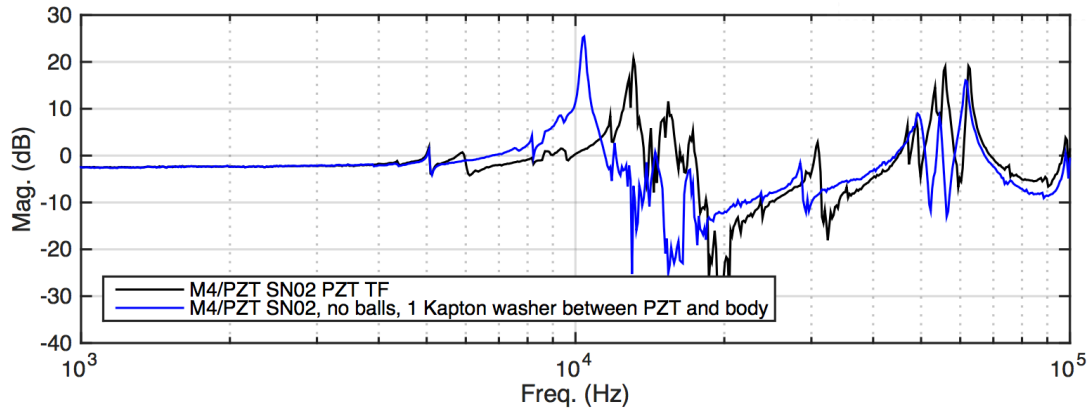
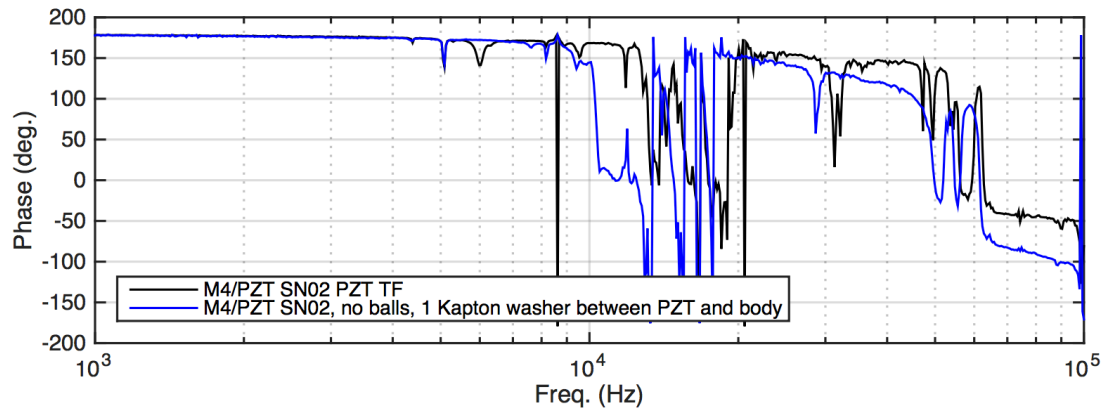
0.010" thick kapton washer between body and PZT

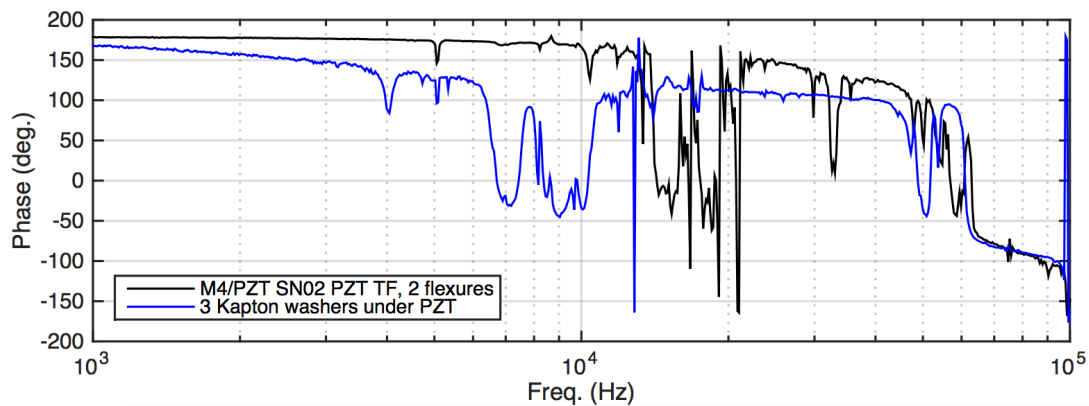
3 Kapton washers under the PZT

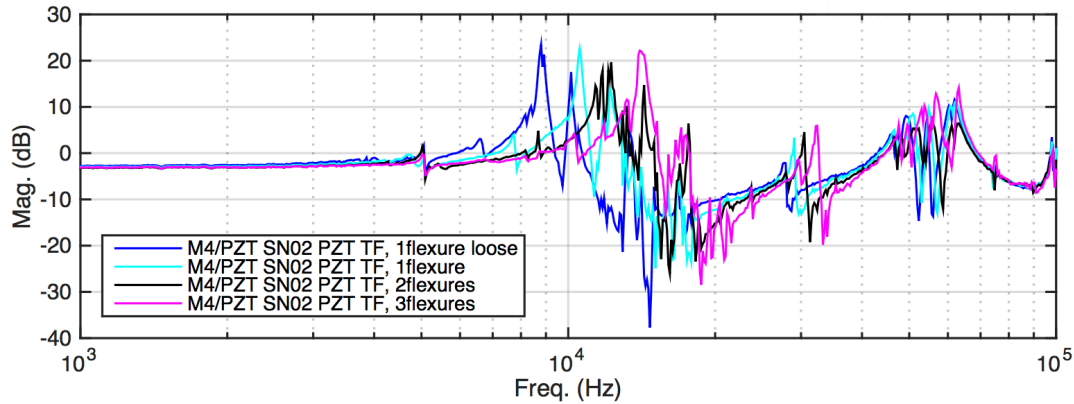
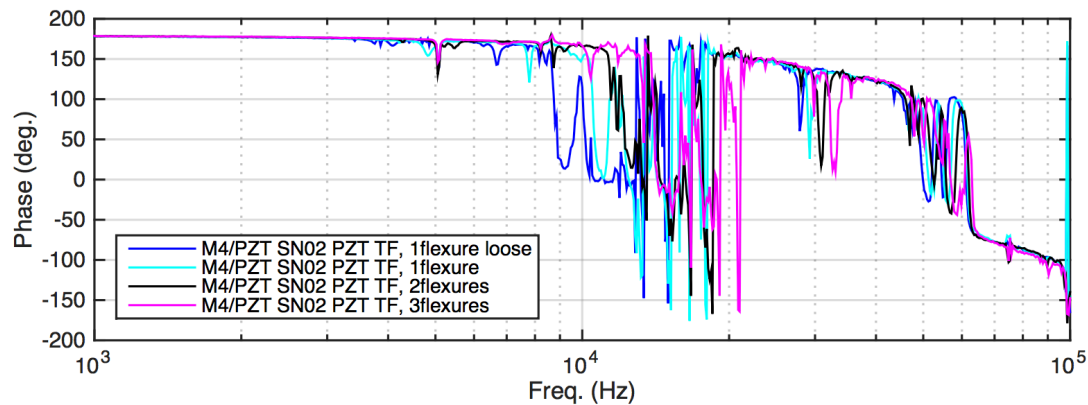
1/2, 1, 2, or 3 flexures? (no balls, no washers)
