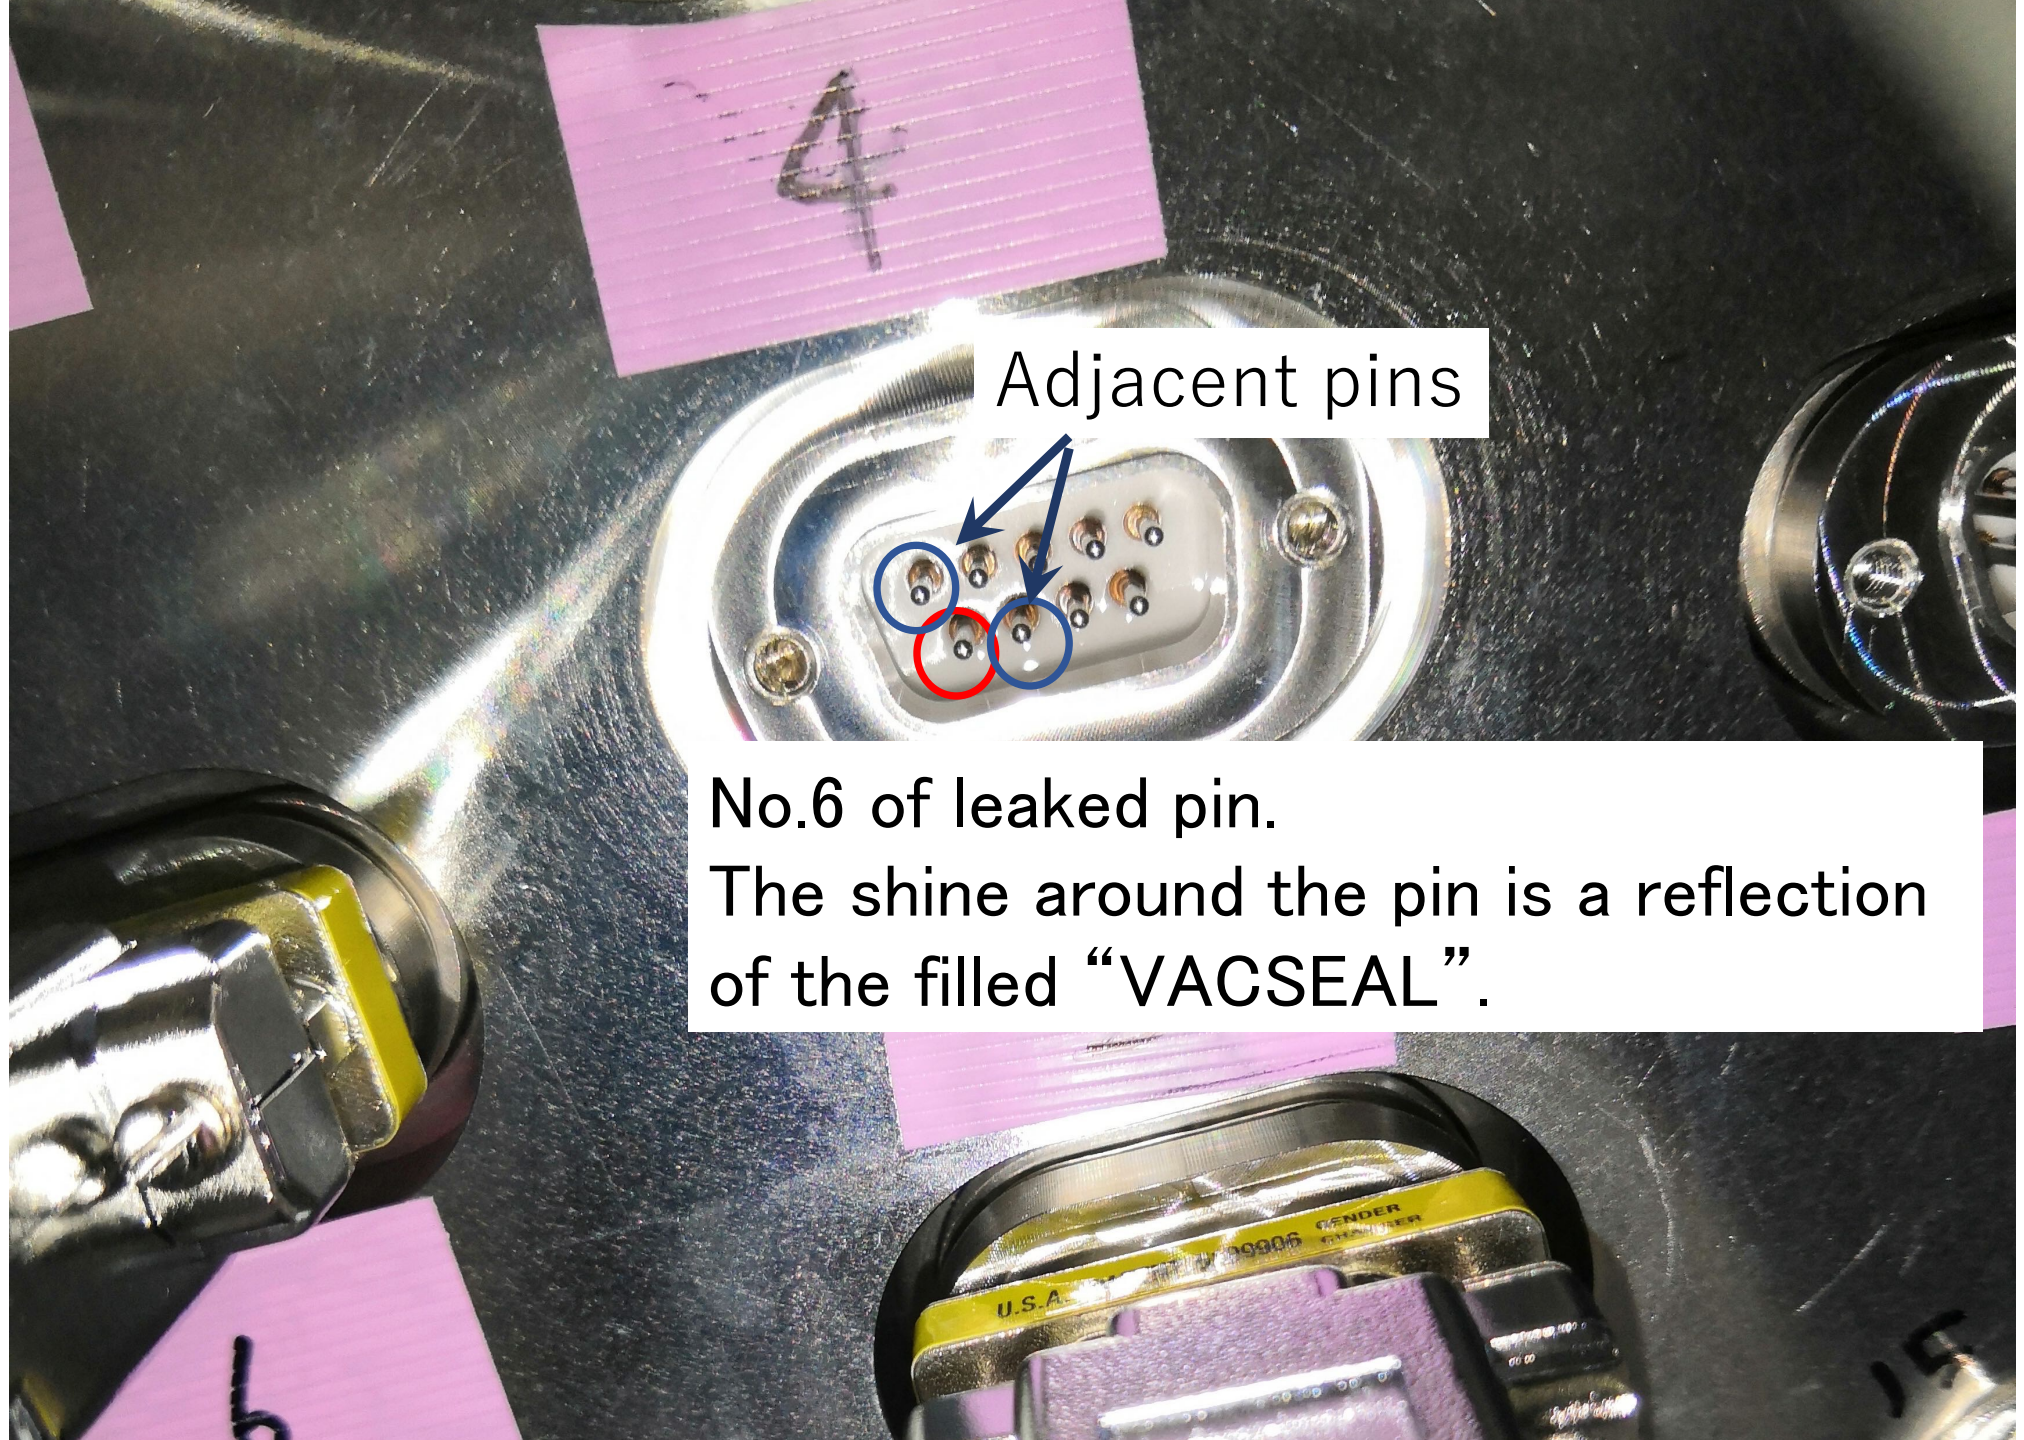
Adjacent pins

No.6 of leaked pin.  
The shine around the pin is a reflection  
of the filled "VACSEAL".

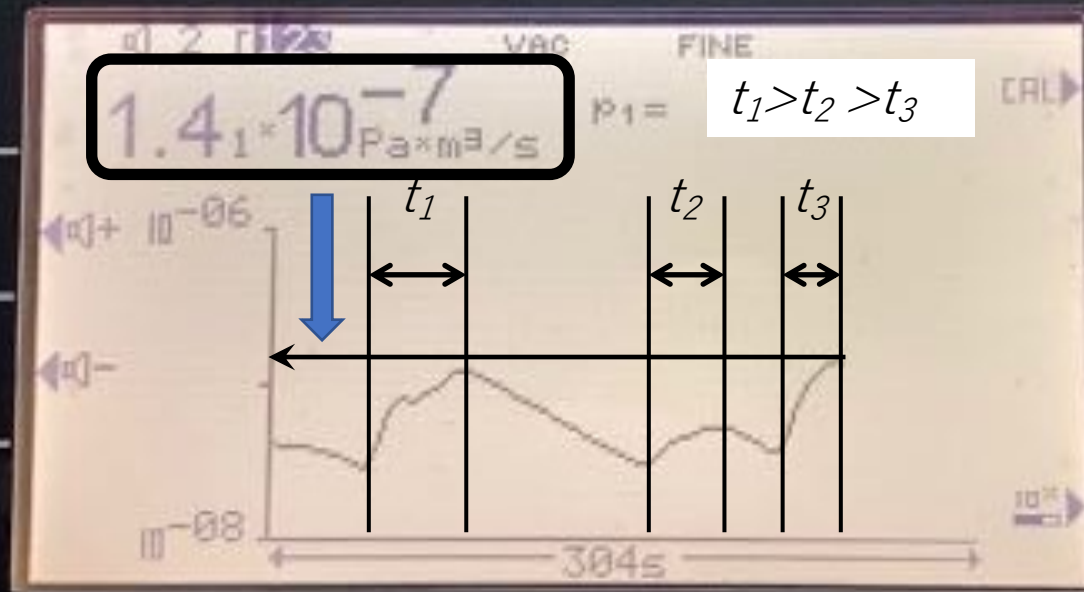
Before repair work

$t_1, t_2$  : Reaction time constant of adjacent pins  
 $t_3$  : Reaction time constant of No.6 of leaked pin

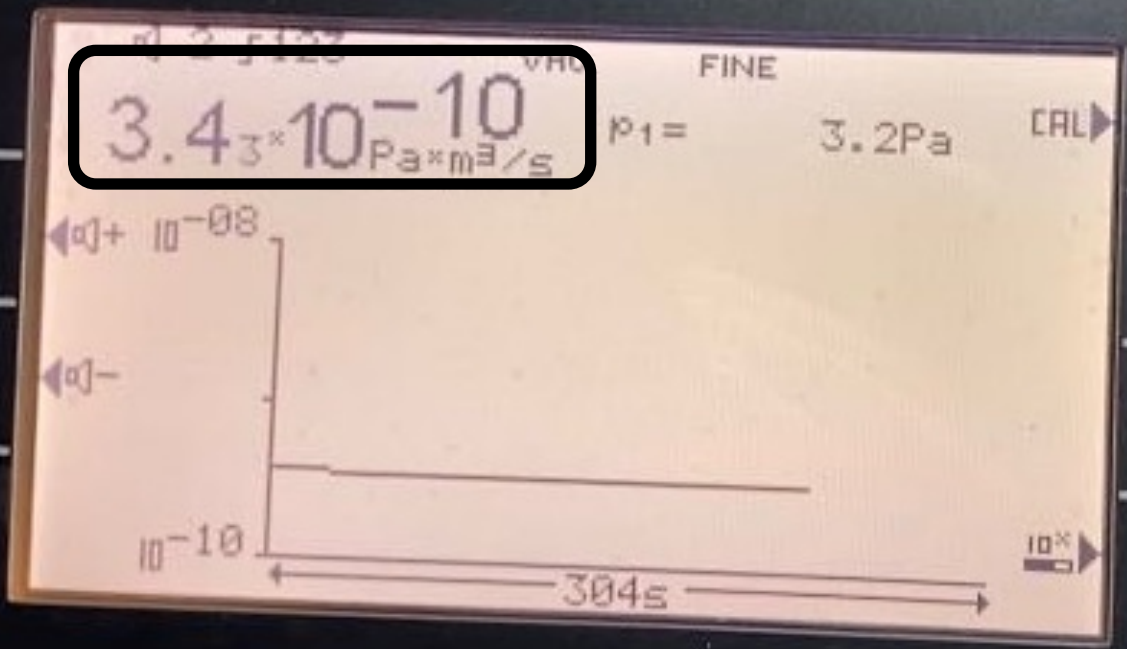
After repair work

No leakage response of No.6 of leaked pin across the background 3.4 x 10<sup>-10</sup> Pam<sup>3</sup>/s was detected after repair work.
