Cleaning of the PRM mirror

2022.5.11~12 Fabian, Hirata, Yasui

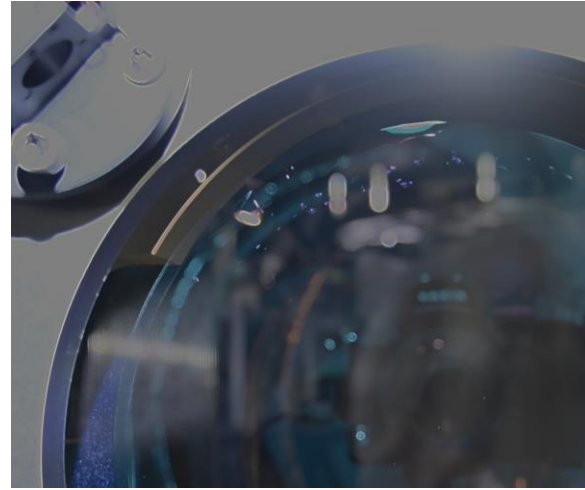
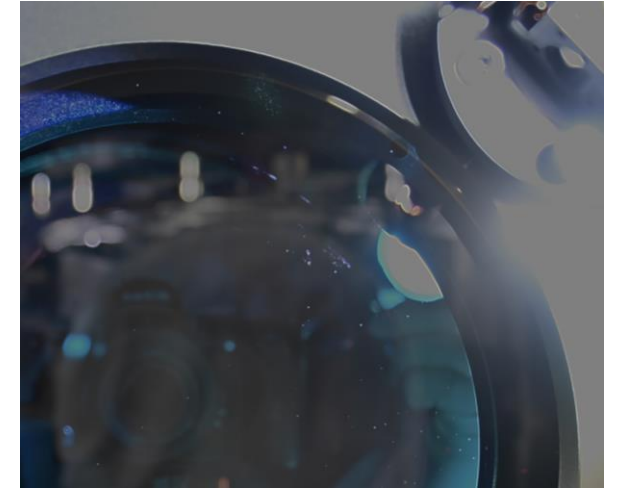
Before(2022.5.11)

There is a lot of dust mainly on its right side, and arc-shaped dirt, maybe FC residue or something, are on its upper side.

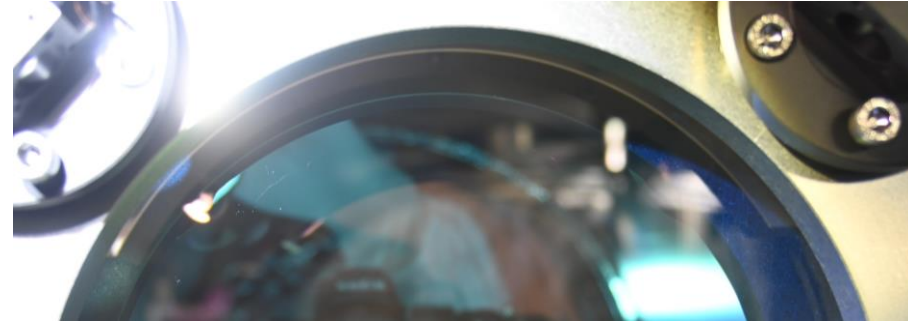
After(2022.5.12)

The center area looks clean. But there is FC residue on its lower right side. And it still has dirt on its upper side and a lot of dust on its lower right that couldn't be found in this picture. Because these are on the out-of-jig range, we couldn't do anything more.
