Cable changes in IX   (Before changing)

Work on June 20. 2021

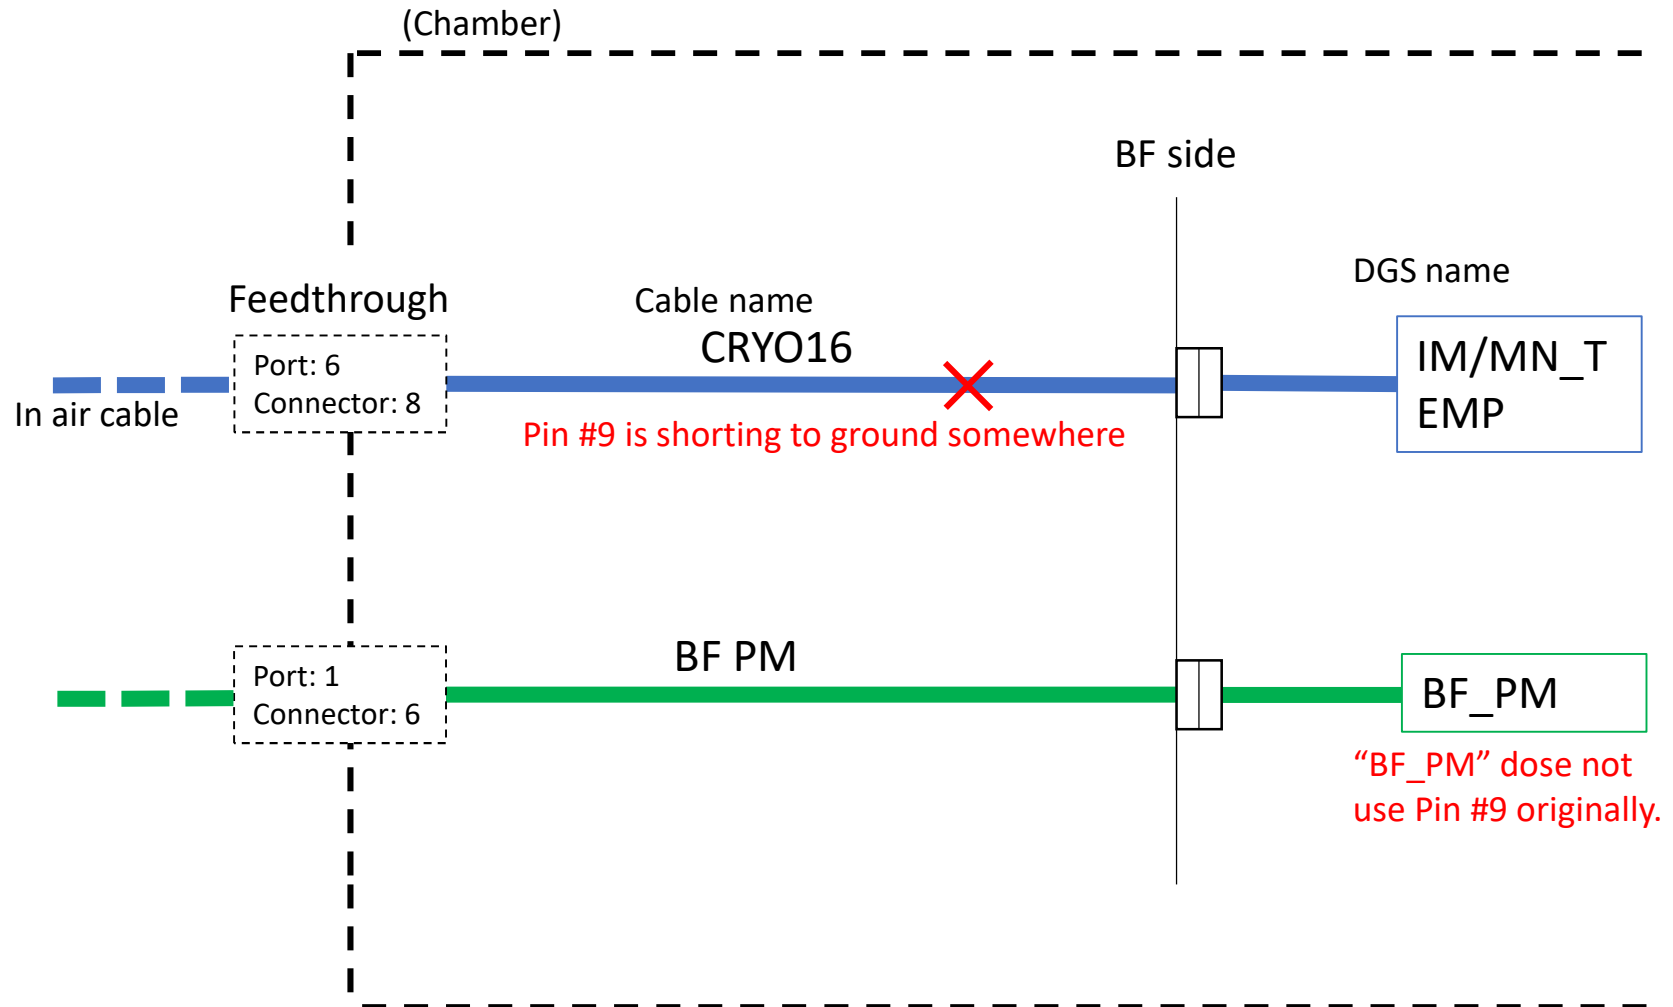
Pin #9 is shorting to ground somewhere

"BF_PM" dose not
use Pin #9 originally.
